**May 7, 2020**

## **The Granville Town Hall, Granville Vermont**

### **A Preservation Trust of Vermont**

#### **Technical Assistance Survey**

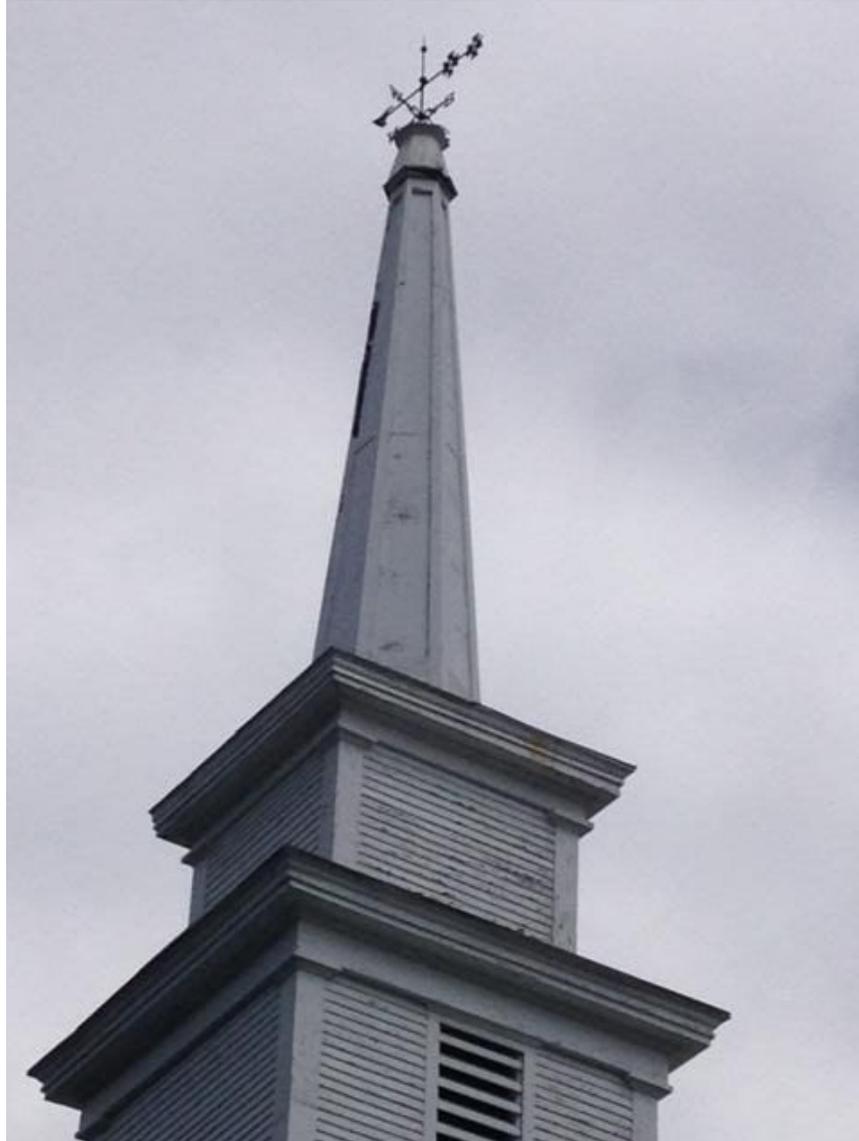
**The framing of the tower stages is composed of 8x8 timbers and 4x4 braces and studs. Due to extensive leakage of the small roofs in the past most of the plates and tops of the posts at both levels had rotted, but have since been repaired in the two campaigns mentioned earlier. Rarely was a complete stick of timber changed but rather a process of cutting off and extending rotted posts, putting lintels of wood or metal under horizontals and supporting missing tenoned connections with bolted on shoulders or steel plates. While the repairs found in the two square stages do not represent the best timber repair, the stages are small and not tall, and there is a tremendous amount of short pieces of wood lagged and screwed to them, such that they are actually quite stable.**

***Granville: Repairs in tower***

**If the metal roof at the base of the spire is removed, it is relatively easy to replace the cobbled together rotted plates of the second stage with length of 8x8 x 7 ft. solid timber.**

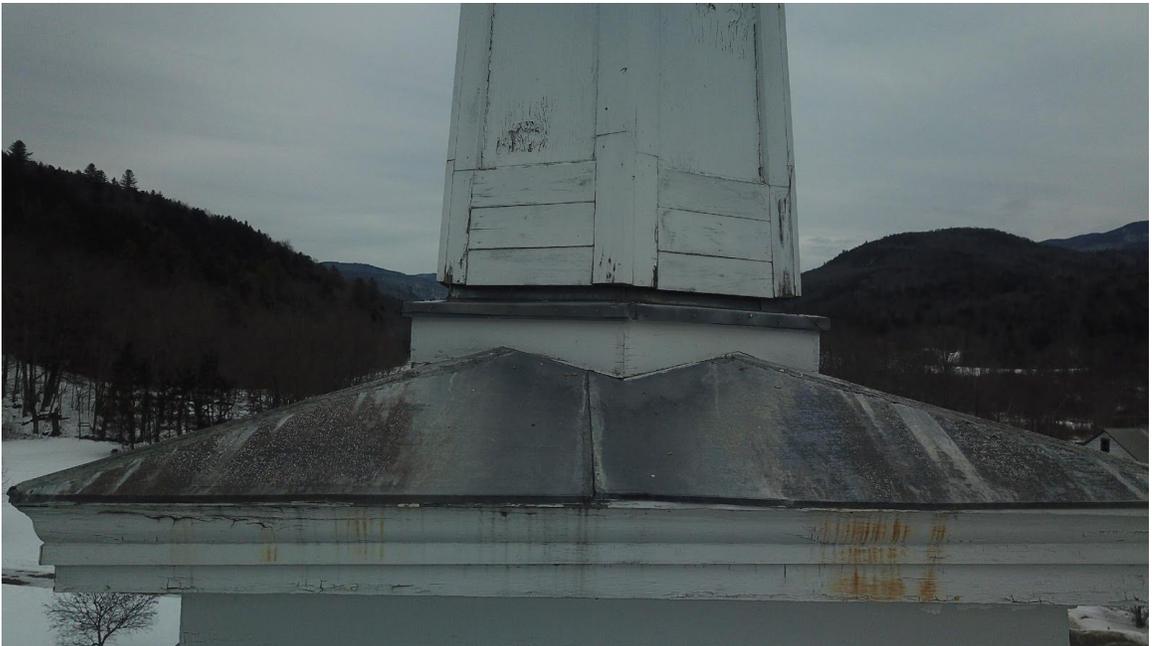
**Once on the ground a decision can be made whether to only work on the spire or to rebuild the first skirting hip roof above the 2<sup>nd</sup> stage. This is a neatly done, soldered seam, metal roof, that for some inexplicable reason is already rusting and bleeding onto the trim below on the south face at**

**least. It seems to be bleeding from the hip seams generally. There is also a large area of rot in the cornice underneath this roof. I would recommend scaffolding to the 25 ft. height of the tower and spire, dismantling this roof and uncovering the spire to see the condition of the rafters at the apex. Dropping a new 8x8 x 25 ft. timber mast in would improve the spire both structurally and historically, and deal with attachment problems at the apex.**

***Granville skirting roof rust***

**Once the woodwork is nearly complete, remetal the stage 2 hip roof with copper or leaded or zinc coated copper. The 3 courses of clapboards covering the flashing of this roof are a good feature.**

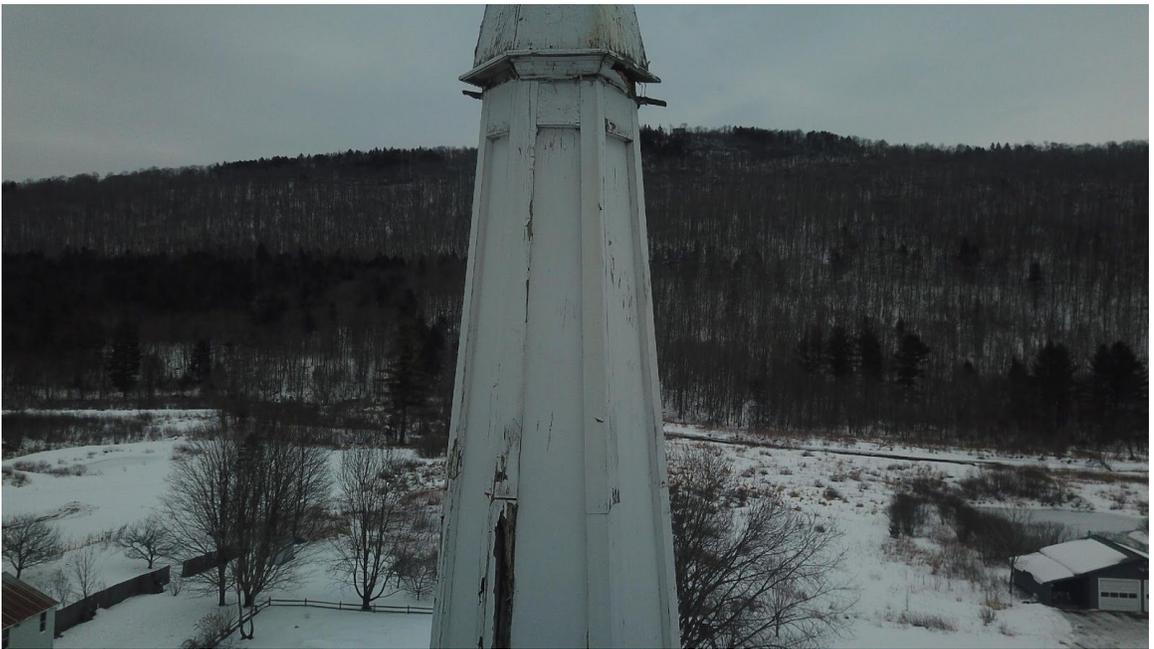
**The hexagonal ornament atop the spire at the weathervane is falling apart, and is not detailed to survive very long, as its horizontal surfaces are completely flat and won't drain at all.**

**The spire has numerous problems: the rotted apex ornament, missing corner trim on the rear and a long area of rotted boarding, as well as a more general problem of 3 levels of small metal roofing that appear completely flat, and will eventually be negatively sloped as things shrink and sag, and introduce water into the spire. The easiest way to deal with all its problems are to lift the spire and the second square to the ground by crane. I know this has been done in the not too distant past but is still the best and most economical way to proceed.**

***Granville spire deterioration***

**The long vertical boarding should be changed over to 6-8-10 inch, 5/4 in. t&g. It is important to avoid exposed butt joints in the boards, so either use full length boards (18 ft. will probably get you within the lower roof) or make a common joint halfway down the spire with a molding and flashing belt course at that point. The corner trim should be 5/4 as well and made of red or white cedar or tamarack. Replace cornice moldings as needed in white pine.**

**Recreate the top ornament and its moldings in a way that sheds water well. This small ornament up high should dry out very well, and its problem may be caused by infiltration at the vane shaft. A metal disk, concave downward, welded to the vane shaft is your best protection.**
