Jan Lewandoski
Restoration and Traditional Building
92 Old Pasture Rd.
Greensboro Bend , Vermont 05842
802-533-2561; 802-274-4318
janlewandoski@gmail.com

The Granville Town Hall, Granville Vermont

A Preservation Trust of Vermont

Technical Assistance Survey

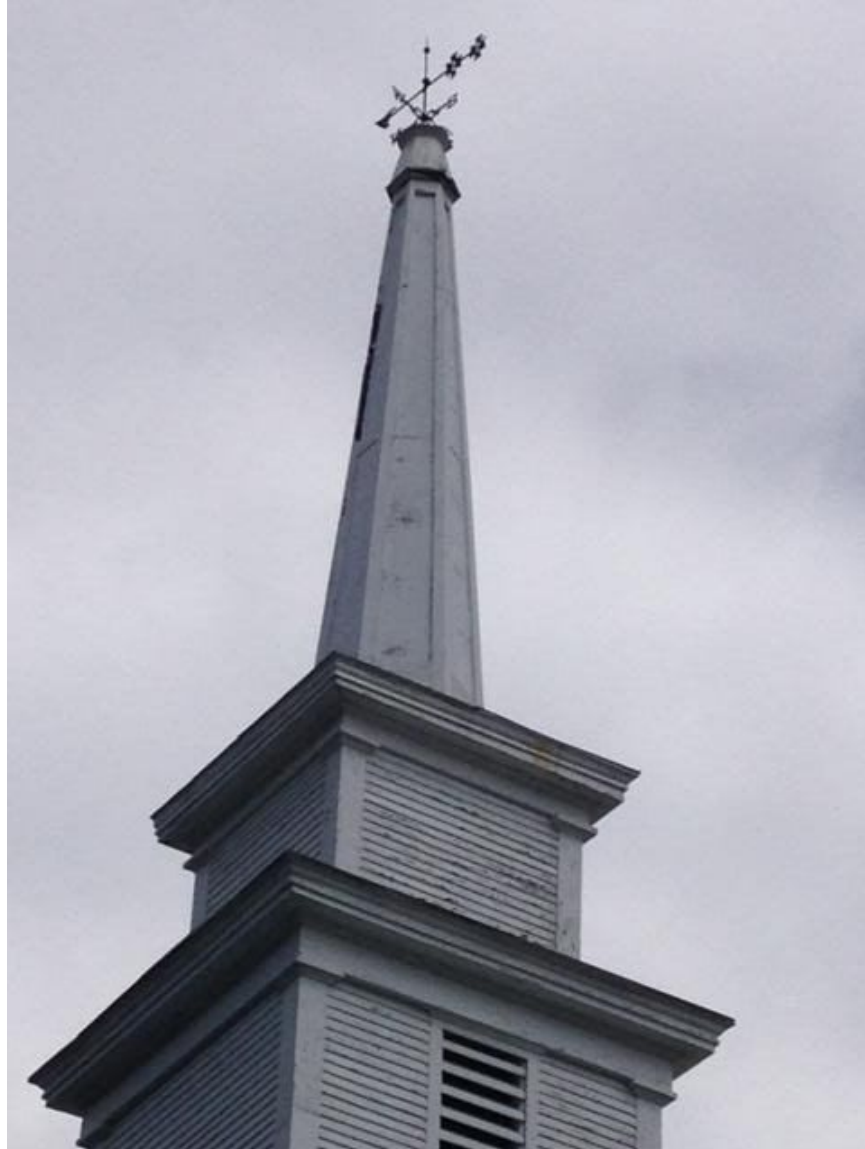
The framing of the tower stages is composed of 8x8 timbers and 4x4 braces and studs. Due to extensive leakage of the small roofs in the past most of the plates and tops of the posts at both levels had rotted, but have since been repaired in the two campaigns mentioned earlier. Rarely was a complete stick of timber changed but rather a process of cutting off and extending rotted posts, putting lintels of wood or metal under horizontals and supporting missing tenoned connections with bolted on shoulders or steel plates. While the repairs found in the two square stages do not represent the best timber repair, the stages are small and not tall, and there is a tremendous amount of short pieces of wood lagged and screwed to them, such that they are actually quite stable.

Granville: Repairs in tower

If the metal roof at the base of the spire is removed, it is relatively easy to replace the cobbled together rotted plates of the second stage with length of 8x8 x 7 ft. solid timber.

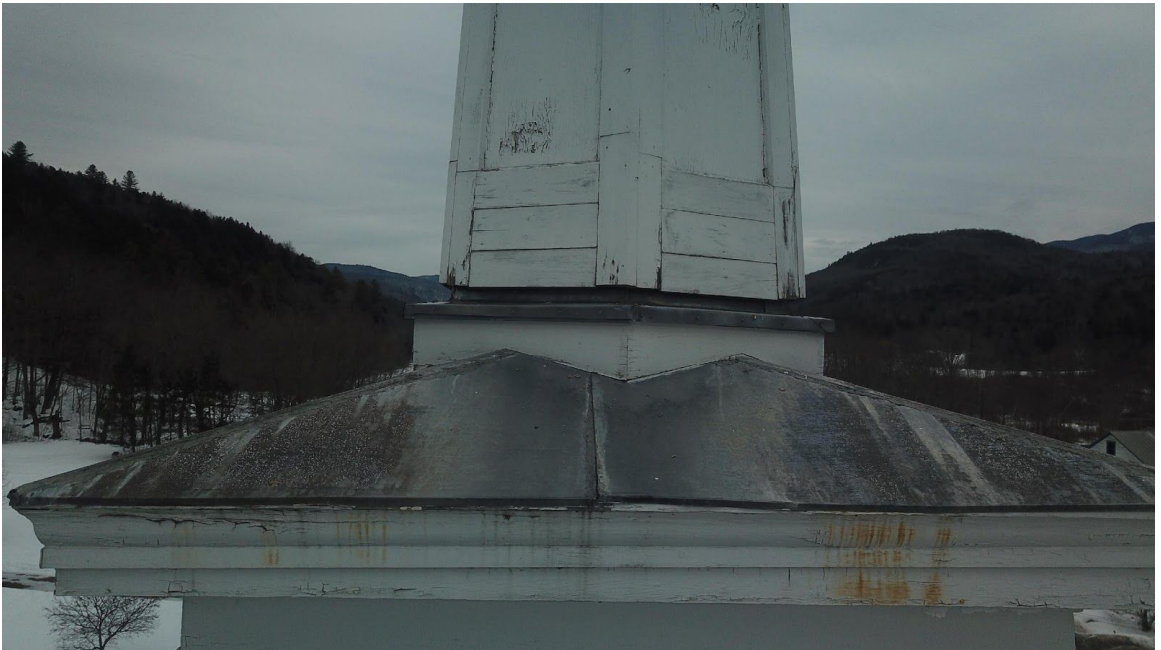
Once on the ground a decision can be made whether to only work on the spire or to rebuild the first skirting hip roof above the 2nd stage. This is a neatly done, soldered seam, metal roof, that for some inexplicable reason is already rusting and bleeding onto the trim below on the south face at

least. It seems to be bleeding from the hip seams generally. There is also a large area of rot in the cornice underneath this roof. I would recommend scaffolding to the 25 ft. height of the tower and spire, dismantling this roof and uncovering the spire to see the condition of the rafters at the apex. Dropping a new 8x8 x 25 ft. timber mast in would improve the spire both structurally and historically, and deal with attachment problems at the apex.

Granville skirting roof rust

Once the woodwork is nearly complete, remetal the stage 2 hip roof with copper or leaded or zinc coated copper. The 3 courses of clapboards covering the flashing of this roof are a good feature.

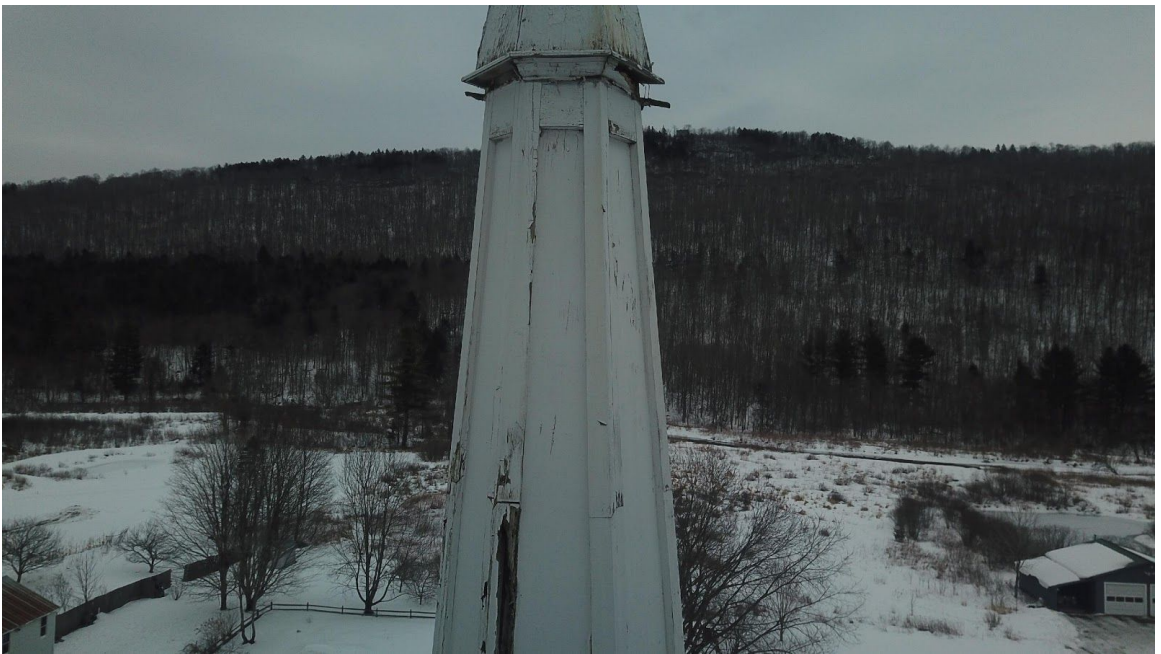
The spire has numerous problems: the rotted apex ornament, missing corner trim on the rear and a long area of rotted boarding, as well as a more general problem of 3 levels of small metal roofing that appear completely flat, and will eventually be negatively sloped as things shrink and sag, and introduce water into the spire. The easiest way to deal with all its problems are to lift the spire and the second square to the ground by crane. I know this has been done in the not too distant past but is still the best and most economical way to proceed.

Granville spire deterioration

While the spire is unboarded, it would be the time to take three small roofs (two on the top ornament and one at the very base of the spire), remove their metal, create a slope with wooden wedges, and remetal them with copper or leaded copper or zinc coated copper.

The long vertical boarding should be changed over to 6-8-10 inch, 5/4 in. t&g. It is important to avoid exposed butt joints in the boards, so either use full length boards (18 ft. will probably get you within the lower roof) or make a common joint halfway down the spire with a molding and flashing belt course at that point. The corner trim should be 5/4 as well and made of red or white cedar or tamarack. Replace cornice moldings as needed in white pine.

Recreate the top ornament and its moldings in a way that sheds water well. This small ornament up high should dry out very well, and its problem may be caused by infiltration at the vane shaft. A metal disk, concave downward, welded to the vane shaft is your best protection.
