**May 7, 2020**

## **The Granville Town Hall, Granville Vermont**

### **A Preservation Trust of Vermont**

#### **Technical Assistance Survey**

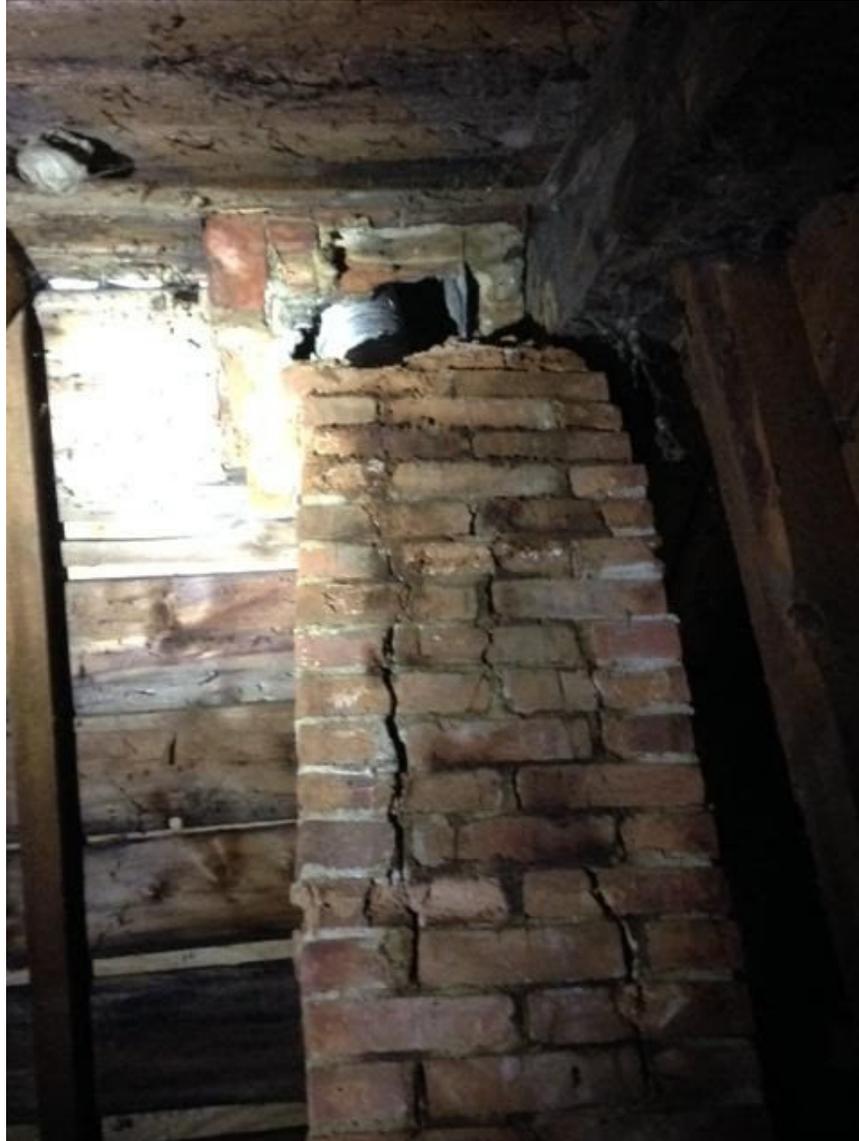
***Granville: chimney failure at attic rear***

- 1. Repairing your chimney and vent is the most pressing problem.**
- 2. Third Interior Truss: Will get worse slowly, but is relatively easy to fix so the sooner the better.**
- 3. Steeple: The steeple is stable and not about to collapse. The exception might be the ornament and weathervane at the top. Water appears to be getting into some trim, and daylight can be seen on top of one of the south roofs, allowing water to blow in around the flashing under certain south wind and rain conditions.**
- 4. Common rafter wedged supports: Not crucial, but relatively inexpensive and easy to do. Will keep the eaves straighter and keep pressure off the flying purlins.**

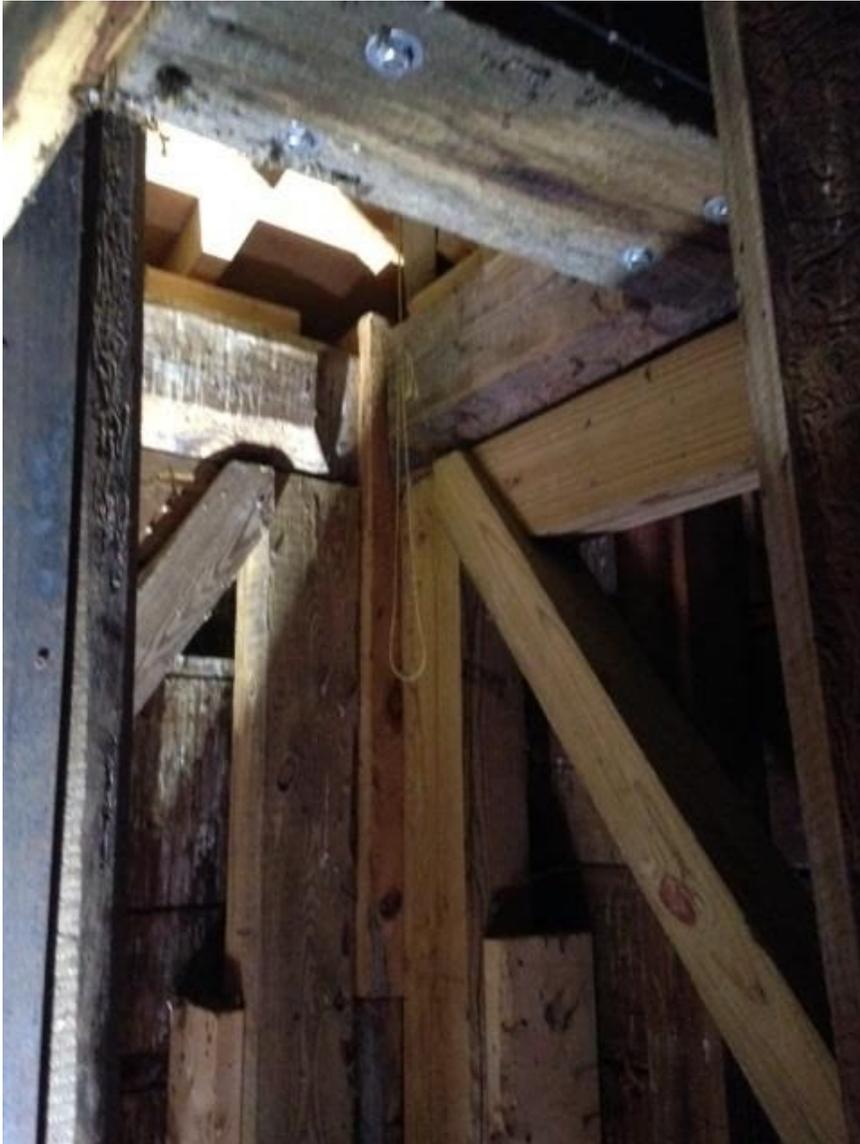
***Granville: Repairs in tower***

**If the metal roof at the base of the spire is removed, it is relatively easy to replace the cobbled together rotted plates of the second stage with length of 8x8 x 7 ft. solid timber.**
