Jan Lewandoski
Restoration and Traditional Building
92 Old Pasture Rd.
Greensboro Bend , Vermont 05842
802-533-2561; 802-274-4318
janlewandoski@gmail.com

The Granville Town Hall, Granville Vermont

A Preservation Trust of Vermont

Technical Assistance Survey

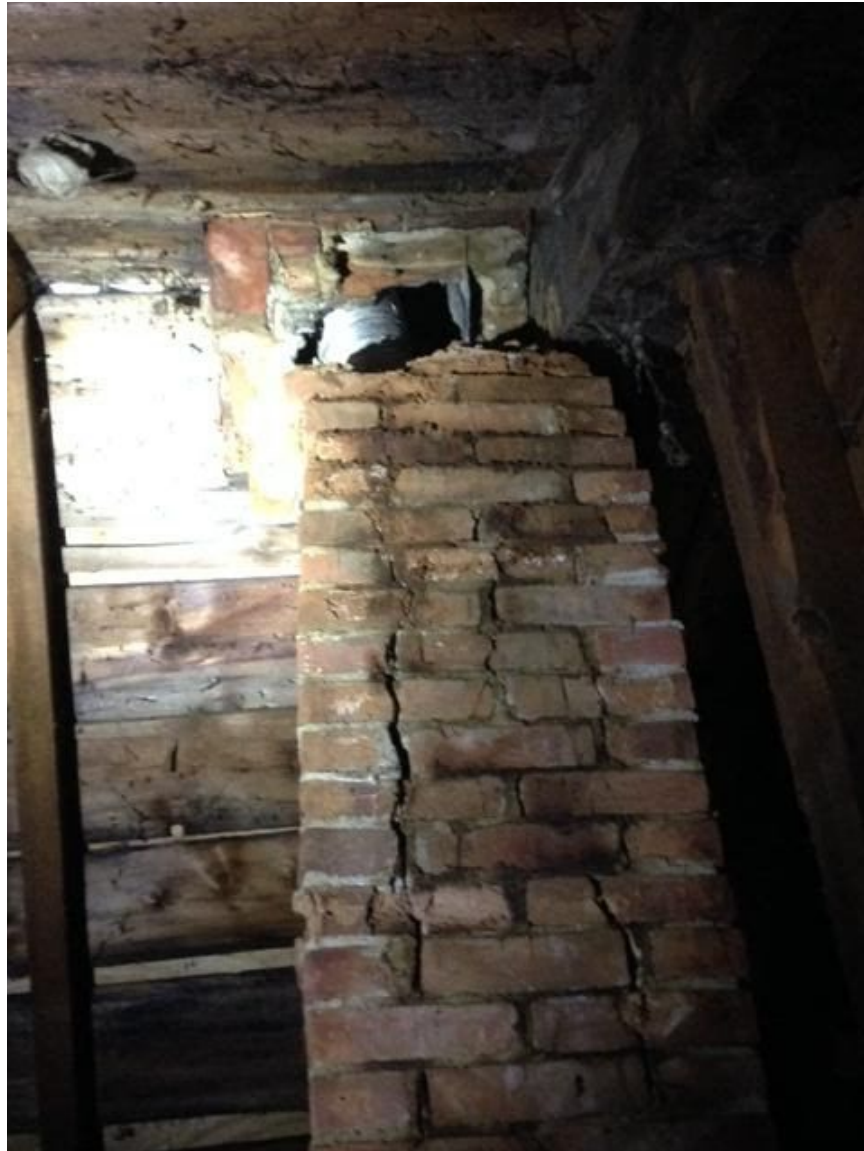
Granville: chimney failure at attic rear

1. Repairing your chimney and vent is the most pressing problem.

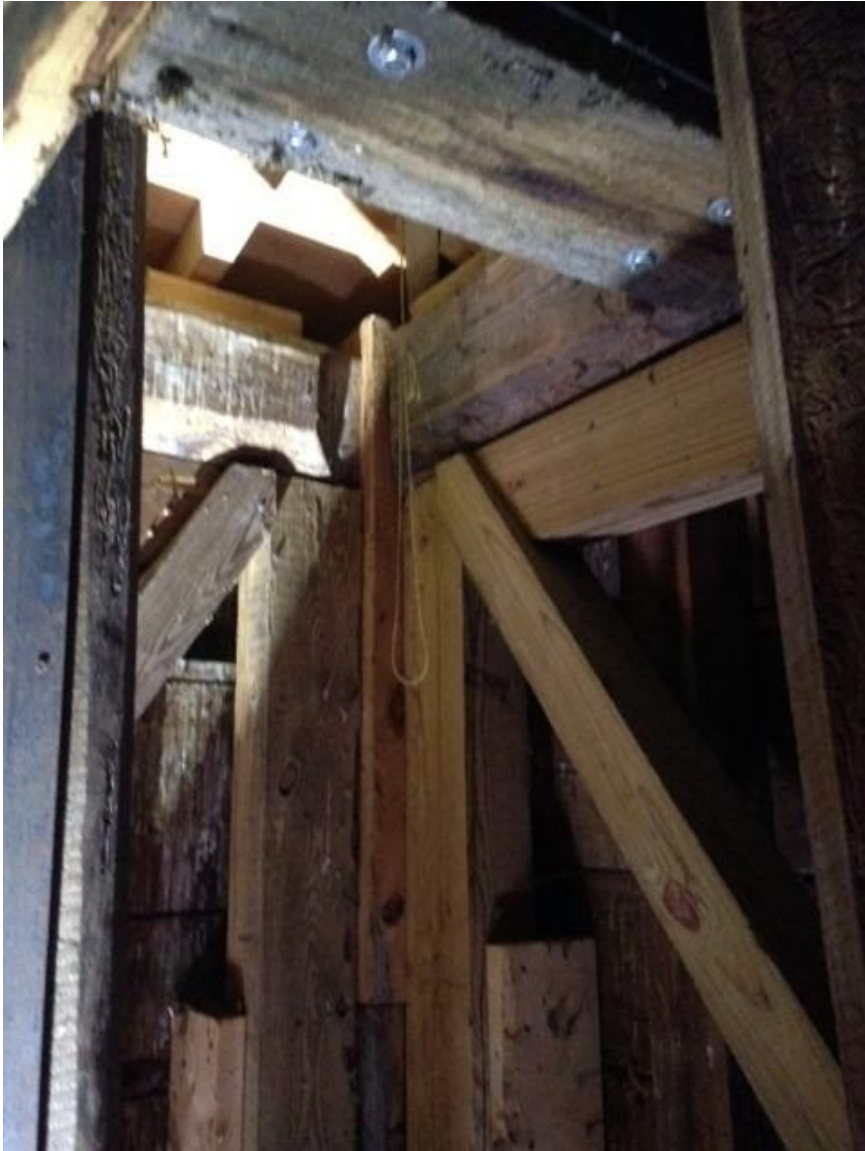
Granville: Repairs in tower

If the metal roof at the base of the spire is removed, it is relatively easy to replace the cobbled together rotted plates of the second stage with length of 8x8 x 7 ft. solid timber.
